**PURPOSE**

There has been a change in the supplier of the start capacitor used on Single Phase PC3 units, implemented to help reduce overall cost to customers. As a result of this change, the new capacitor differs in physical size and can no longer be mounted to the motherboard in the same manner as the previous version. This change required a new part number to be assigned to the updated capacitor.

- PC3

5220 MOTHERBOARD ASSY;1PH

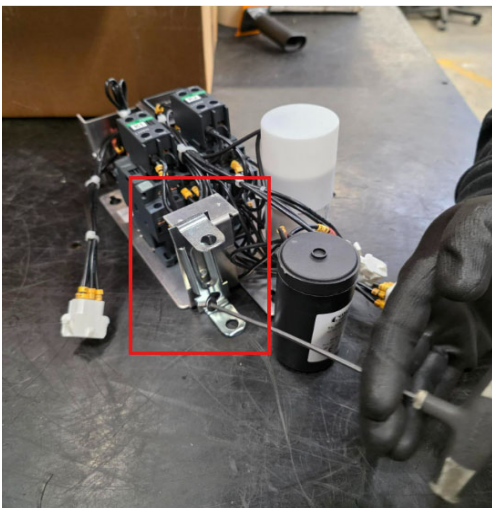
### Step 1 – Capacitor Bracket Removal

Using a 4 mm T-handle, remove the capacitor bracket housing P/N 5882 as shown below.

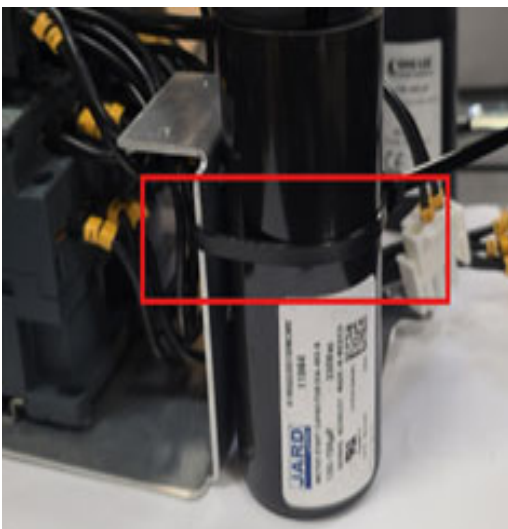
### Step 2 – Capacitor Installation to Bracket

Once the bracket is removed, secure the new capacitor (P/N 726182-1) to the existing bracket using cable tie (P/N 5851), as shown below. Ensure the excess cable tie stem is trimmed flush after installation.

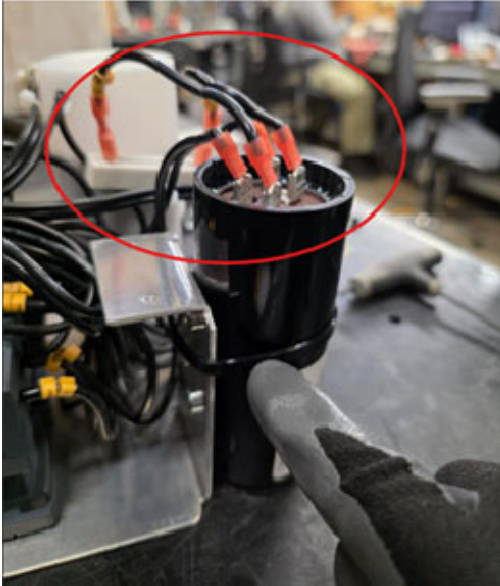
### Step 3 – Capacitor Preparation

Prior to disconnecting any wiring from the existing capacitor, document the wire configuration. This can be accomplished by labeling them per contact orientation.

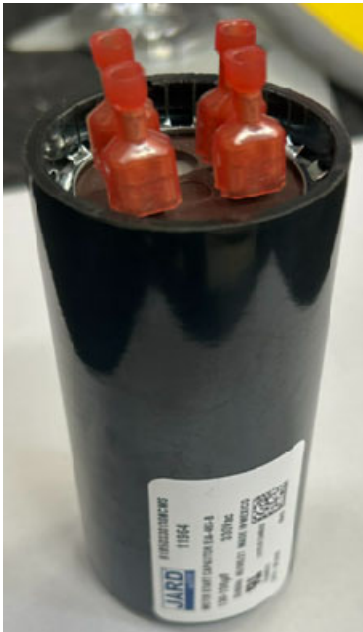
### Step 4 – Electrical Connections

If the terminals were not insulated fully, replace and connect the wires with new fully insulated connectors as shown to the corresponding terminals on the new capacitor (P/N 726182-1), ensuring proper placement per the original configuration. - **FINISHED**
