SAFETY ALERT

PCU 26-009

UpPro OSL – STOP USE – Inspection Required

November 13, 2026

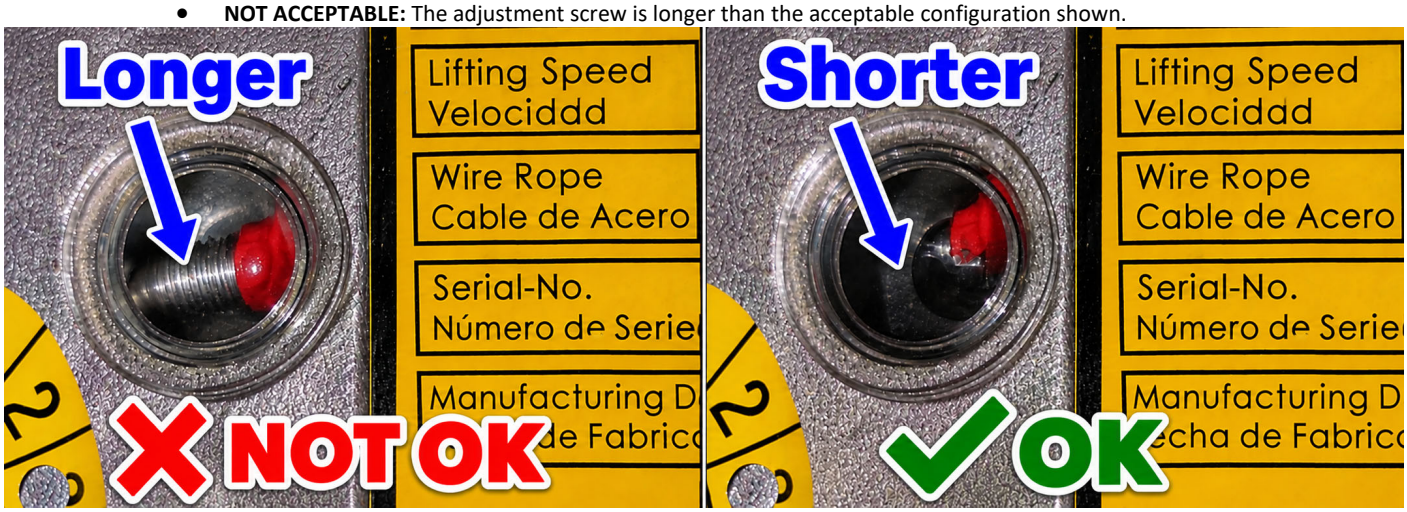
1. **Locate the Adjustment Screw**
   a. With a wire rope in the OSL, look through the OSL inspection window and determine whether the adjustment screw and nut are visible, as illustrated below.
   b. If the adjustment screw is not visible, slowly move the wire rope through the OSL until the screw becomes visible.
2. **Inspect the Adjustment Screw**
   a. Once the adjustment screw is visible, compare its length against the acceptance criteria illustrated below.
   - **ACCEPTABLE:** The adjustment screw is shorter and the length is close to the nut as shown in the configuration below.
   - **NOT ACCEPTABLE:** The adjustment screw is longer than the acceptable configuration shown.

3. **Take Appropriate Action**
   - **If ACCEPTABLE:** The unit meets the inspection criteria outlined in this bulletin and may be returned to service, provided the pre-use/daily check has been satisfied.
   - **If NOT ACCEPTABLE: DO NOT USE THE UNIT.** Keep the UpPro OSL out of service and reach us at the email below for next steps.
     - Americas: ProductSupport@PowerClimber.com
     - EMEA/APAC: GlobalSupport@PowerClimber.com

Do not attempt to adjust, modify, or repair the adjustment screw or nut. Any unit that does not meet the acceptance criteria must remain out of service until further instructions and authorization have been provided.
